COLUMBIA LOCK AND DAM OUACHITA-BLACK RIVER

Ryan Reves, P.E.

Dam Safety Program Manager
Vicksburg District

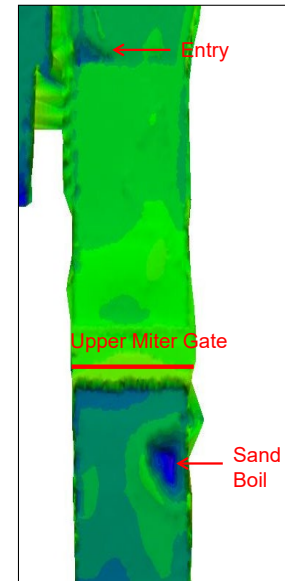
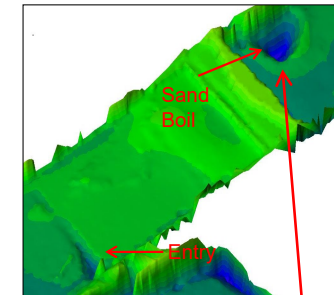
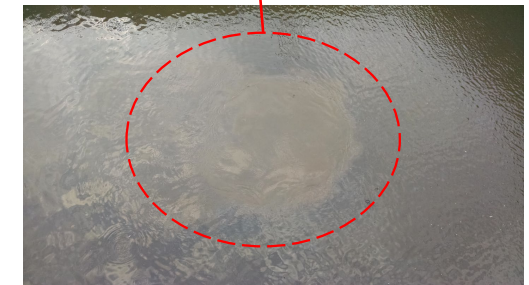
- Issue first discovered November 2015.
- Lock master saw a plume of material inside the lock chamber.
- Performed multi-beam survey of the project.
- Lock closed to navigation for repairs

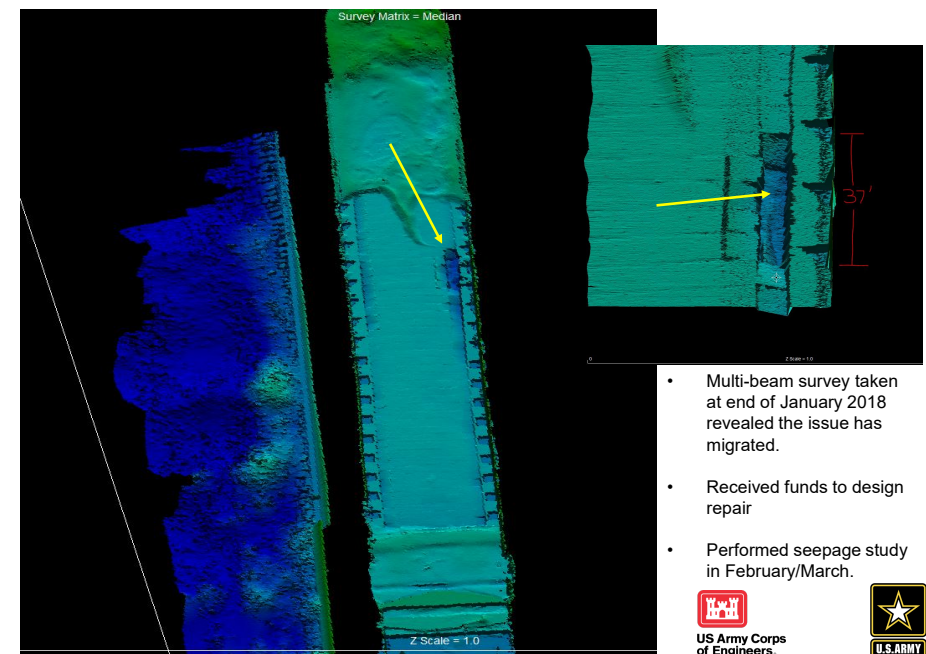
- Multi-beam survey taken at end of January 2018 revealed the issue has migrated.
- Received funds to design repair
- Performed seepage study in February/March.

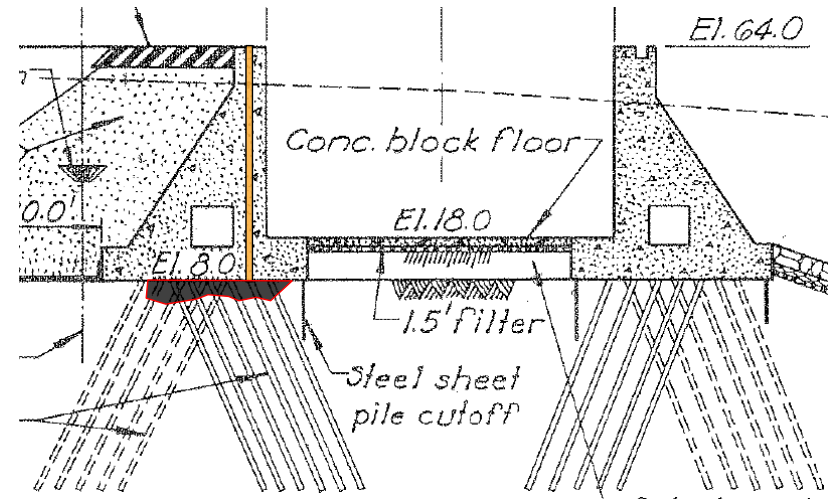
Lock cross-section

- These voids are not supposed to be here.
- Completely changed our understanding of the progression of the situation.

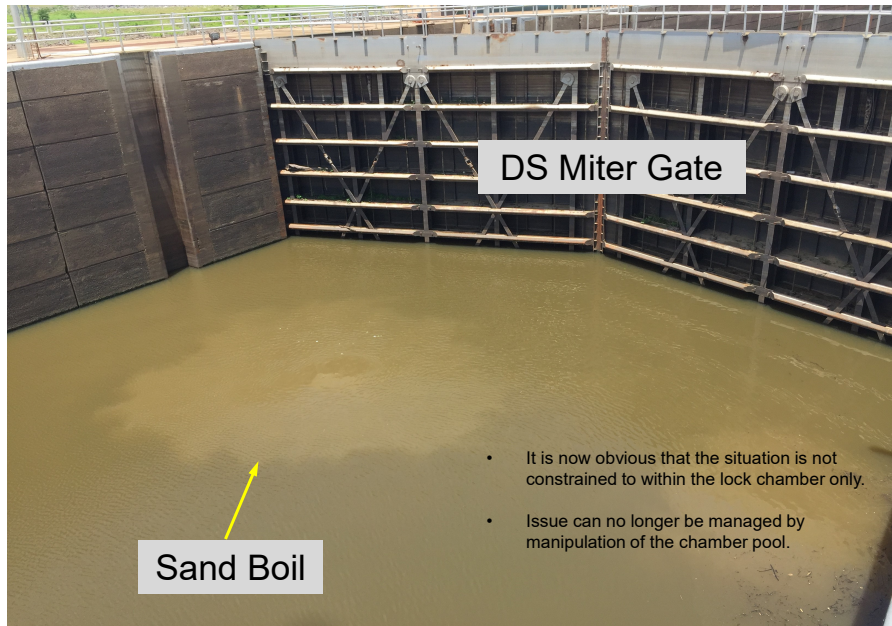
Sand Boil

- It is now obvious that the situation is not constrained to within the lock chamber only.
- Issue can no longer be managed by manipulation of the chamber pool.

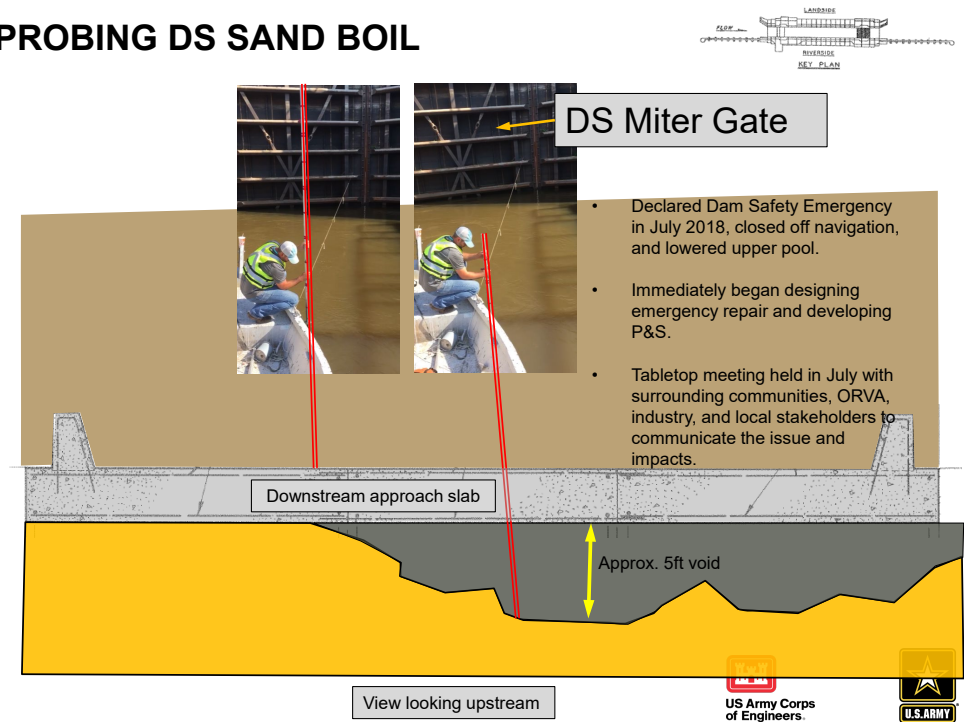
Approx. 5ft void

- Declared Dam Safety Emergency in July 2018, closed off navigation, and lowered upper pool.
- Immediately began designing emergency repair and developing P&S.
- Tabletop meeting held in July with surrounding communities, ORVA, industry, and local stakeholders to communicate the issue and impacts.
