COLUMBIA LOCK AND DAM OUACHITA-BLACK RIVER

Ryan Reves, P.E.

Dam Safety Program Manager
Vicksburg District

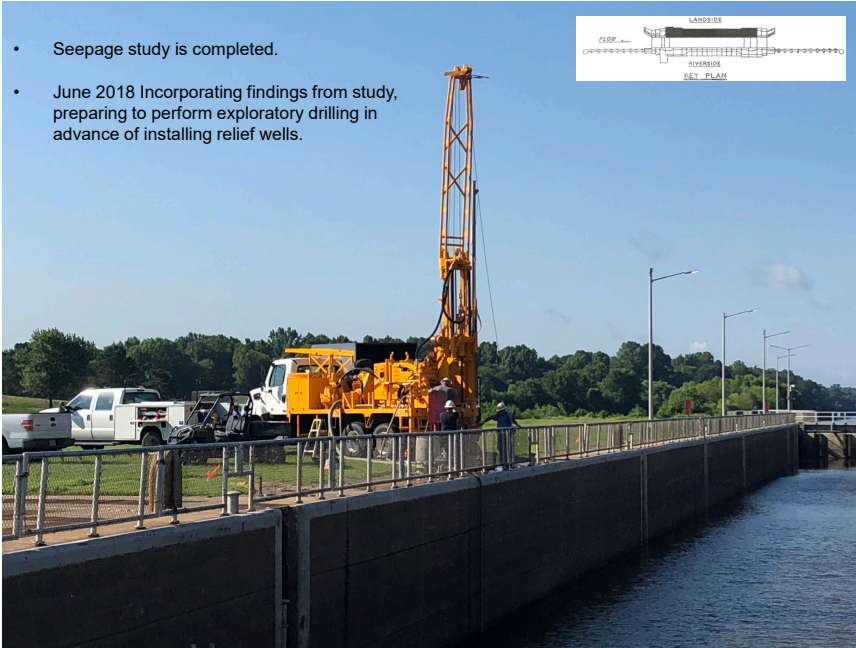
- Seepage study is completed.
- June 2018 Incorporating findings from study, preparing to perform exploratory drilling in advance of installing relief wells.
